**LIMITED PRE-RENOVATION HAZARDOUS BUILDING MATERIALS ASSESSMENT**

Centennial Centre  
2805 Carlow Road Victoria, BC

Project File: LANG25-02r01

November 6, 2024

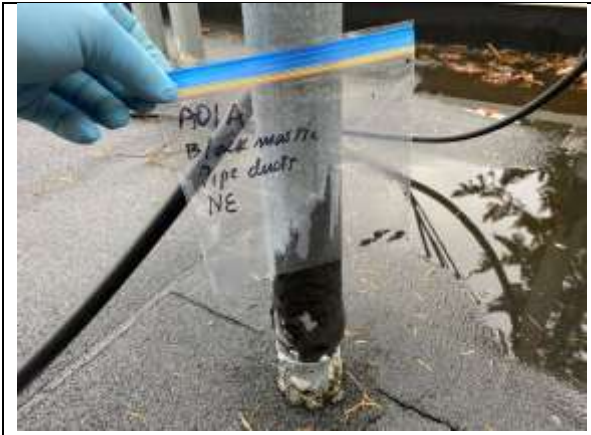
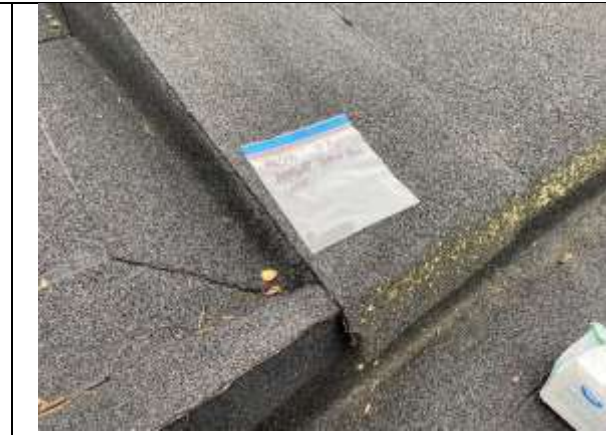
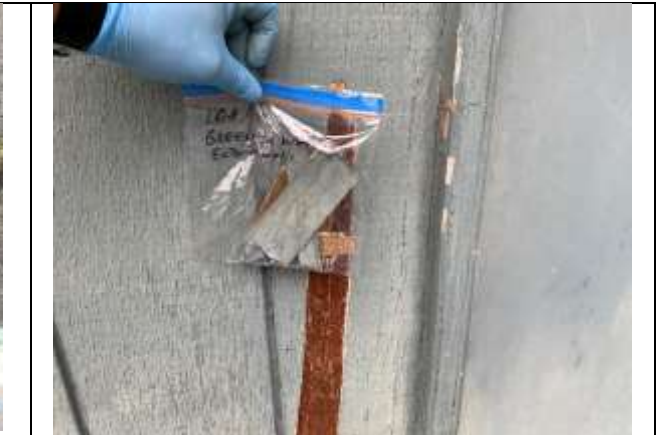
| <p><b>Sample:</b> A01A<br/><b>Location:</b> Roof – Electrical pipes<br/><b>Description:</b> Black mastic<br/><b>Hazardous Material:</b> None found</p> | <p><b>Sample:</b> A03B<br/><b>Location:</b> Roof<br/><b>Description:</b> Asphalt membrane<br/><b>Hazardous Material:</b> None found</p> | <p><b>Sample:</b> L01<br/><b>Location:</b> Exterior Siding<br/><b>Description:</b> Green on Wood<br/><b>Hazardous Material:</b> Lead (&lt;82 ppm)</p> |

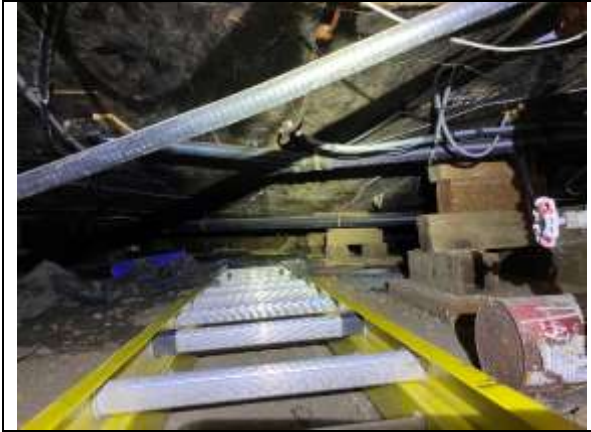
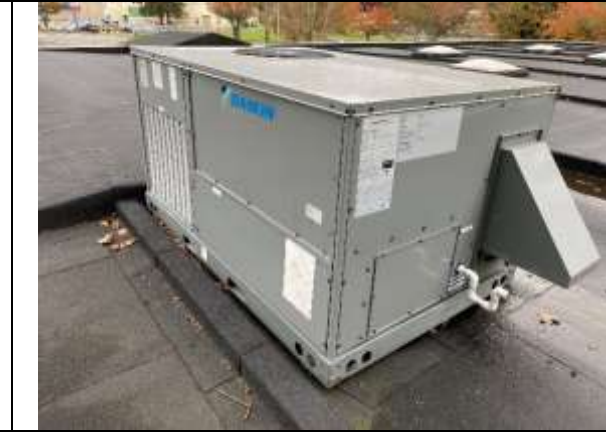
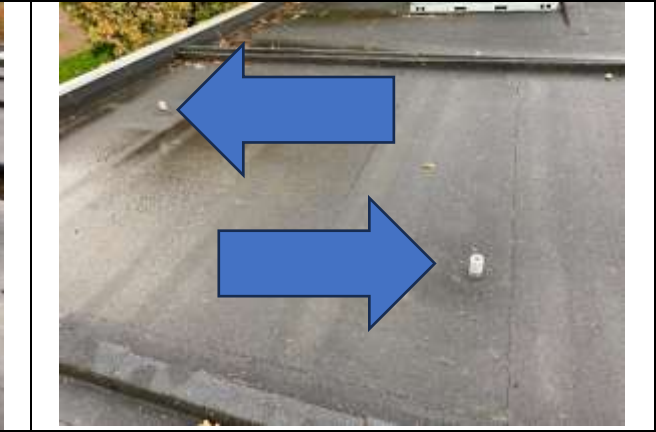
| <p><b>Sample:</b> Visual identification<br/><b>Location:</b> Crawlspace<br/><b>Description:</b> Paint bucket<br/><b>Hazardous Material:</b> Flammables and Explosives</p> | <p><b>Sample:</b> Visual identification<br/><b>Location:</b> Roof<br/><b>Description:</b> Air conditioner/Roof Top Unit<br/><b>Hazardous Material:</b> Halocarbons</p> | <p><b>Sample:</b> L01<br/><b>Location:</b> Roof<br/><b>Description:</b> Lead sewer exhaust pipes<br/><b>Hazardous Material:</b> Lead</p> |

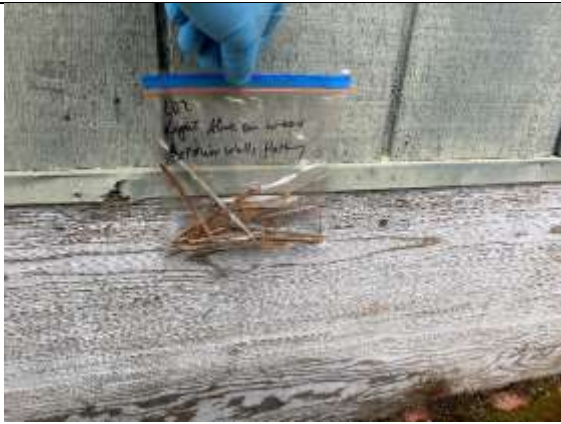
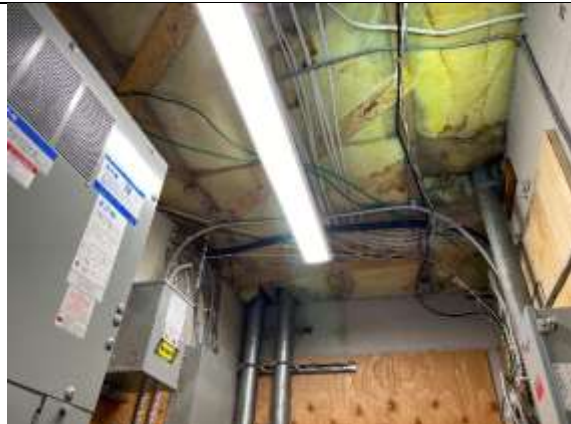
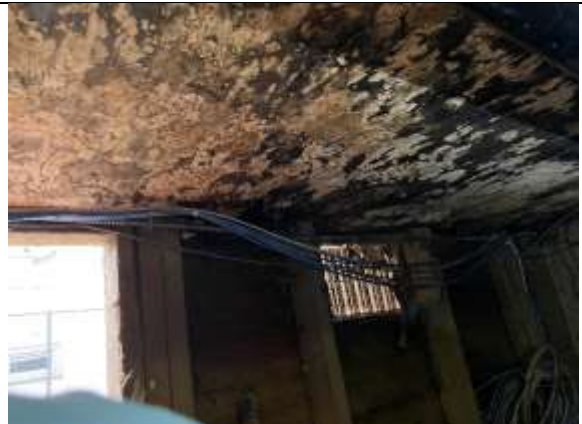
| <p><b>Sample:</b> L02<br/> <b>Location:</b> Exterior Siding<br/> <b>Description:</b> Light Blue on Wood<br/> <b>Hazardous Material:</b> Lead (&lt;82 ppm)</p> | <p><b>Sample:</b> Visual identification<br/> <b>Location:</b> MCC<br/> <b>Description:</b> Stains on ceiling<br/> <b>Hazardous Material:</b> Water damage (Mould potential)</p> | <p><b>Sample:</b> Visual identification<br/> <b>Location:</b> Crawlspace<br/> <b>Description:</b> Dark staining on subfloor of trailers<br/> <b>Hazardous Material:</b> Mould (suspect)</p> |
