File No.: 81115

**2805 CARLOW ROAD, LANGFORD, BC
GEOTECHNICAL REPORT**

We understand that MHS, in partnership with the City of Langford, is planning to redevelop the northern portion of 2805 Carlow Road in Langford, BC. The proposed development will consist of a six-storey building with a single level of underground parking and include up to 40 residential units on Levels 2 to 6 and a licensed childcare facility on the ground level.

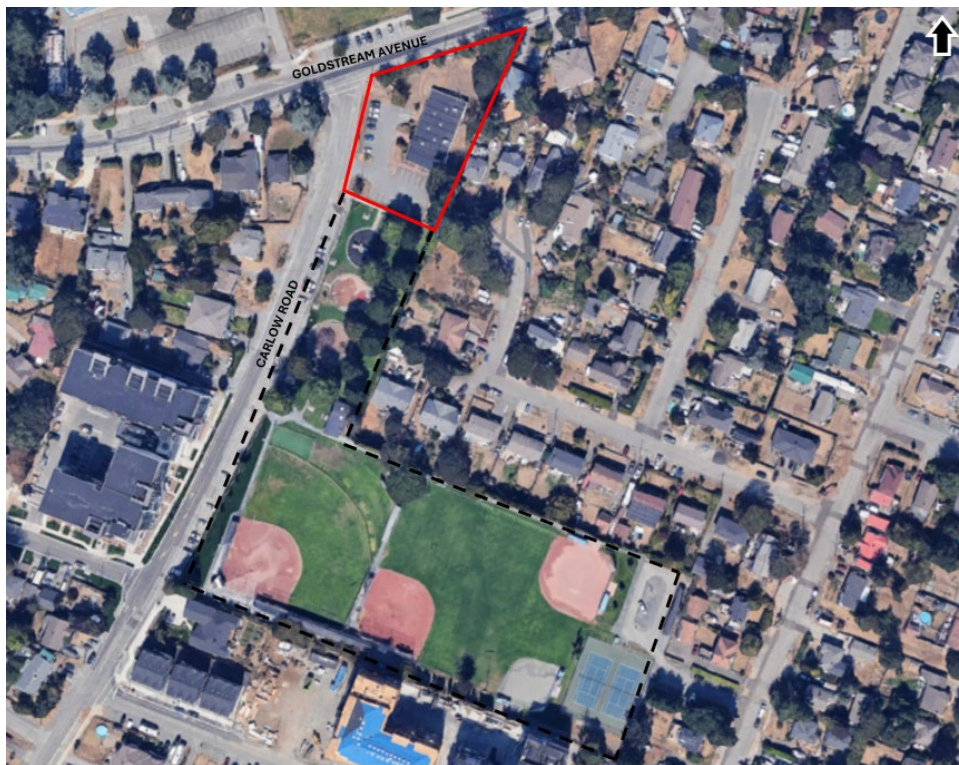
Figure 1.2: Image of the redevelopment Site outlined in red in reference to the remainder of the lot at civic address 2805 Carlow Road, outlined in black (image courtesy of Google Earth).

The lot at civic address 2805 Carlow Road is approximately L-shaped and is currently developed with a single-storey building, an at-grade parking lot, a splash pad and playground, two tennis courts and a baseball diamond. We understand that the proposed development area (the Site) is limited to the northern portion of the overall lot, as shown below in Figure 1.2.

The Site is irregular in shape and is bordered by Goldstream Avenue to the north, Carlow Road to the West, residential buildings to the east, and a splash park/playground to the south. Langford Lake is approximately 0.8 km to the west, Florence Lake is approximately 0.7km north, and Glen Lake is approximately 1.2 km southwest of the Site.

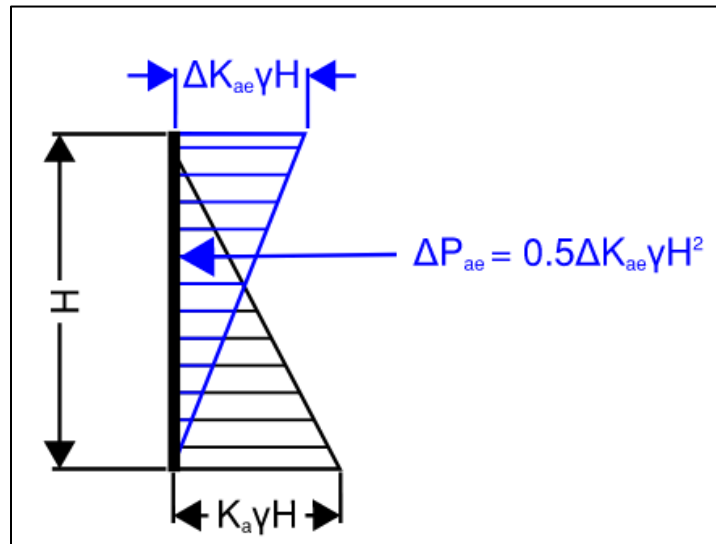
Figure 5.3: Inverted triangle distribution for dynamic loading

An inverted triangular distribution can be assumed for dynamic loading, as shown in Figure 5.3 below. If considered advantageous, a tip-over analysis using the drift limits for the building can be applied to determine an effective reaction spring from the soil at the drift limits. This spring can then be used to determine how much overturning resistance is provided by the soils when designing the structures.

The non-seismic static lateral earth pressures for the proposed underground parkade can be calculated as an equivalent hydrostatic pressure using an equivalent fluid density of 7.3 kN/m³ for yielding walls (active soil pressures) and 11 kN/m³ for non-yielding walls (at-rest soil pressures). Non-yielding walls should have a minimum lateral pressure of 12 kPa to account for soil compaction near the wall. Compaction-induced lateral pressures are those due to surcharge loading and are not additive. These values assume a 22 kN/m³ soil unit weight, an active earth pressure coefficient (K_a) of 0.33 and an at-rest earth pressure (K_o) of 0.5 and a passive earth pressure (K_p) of 3. The static and seismic lateral active soil pressure coefficients have been summarized in Table 5.3 below.

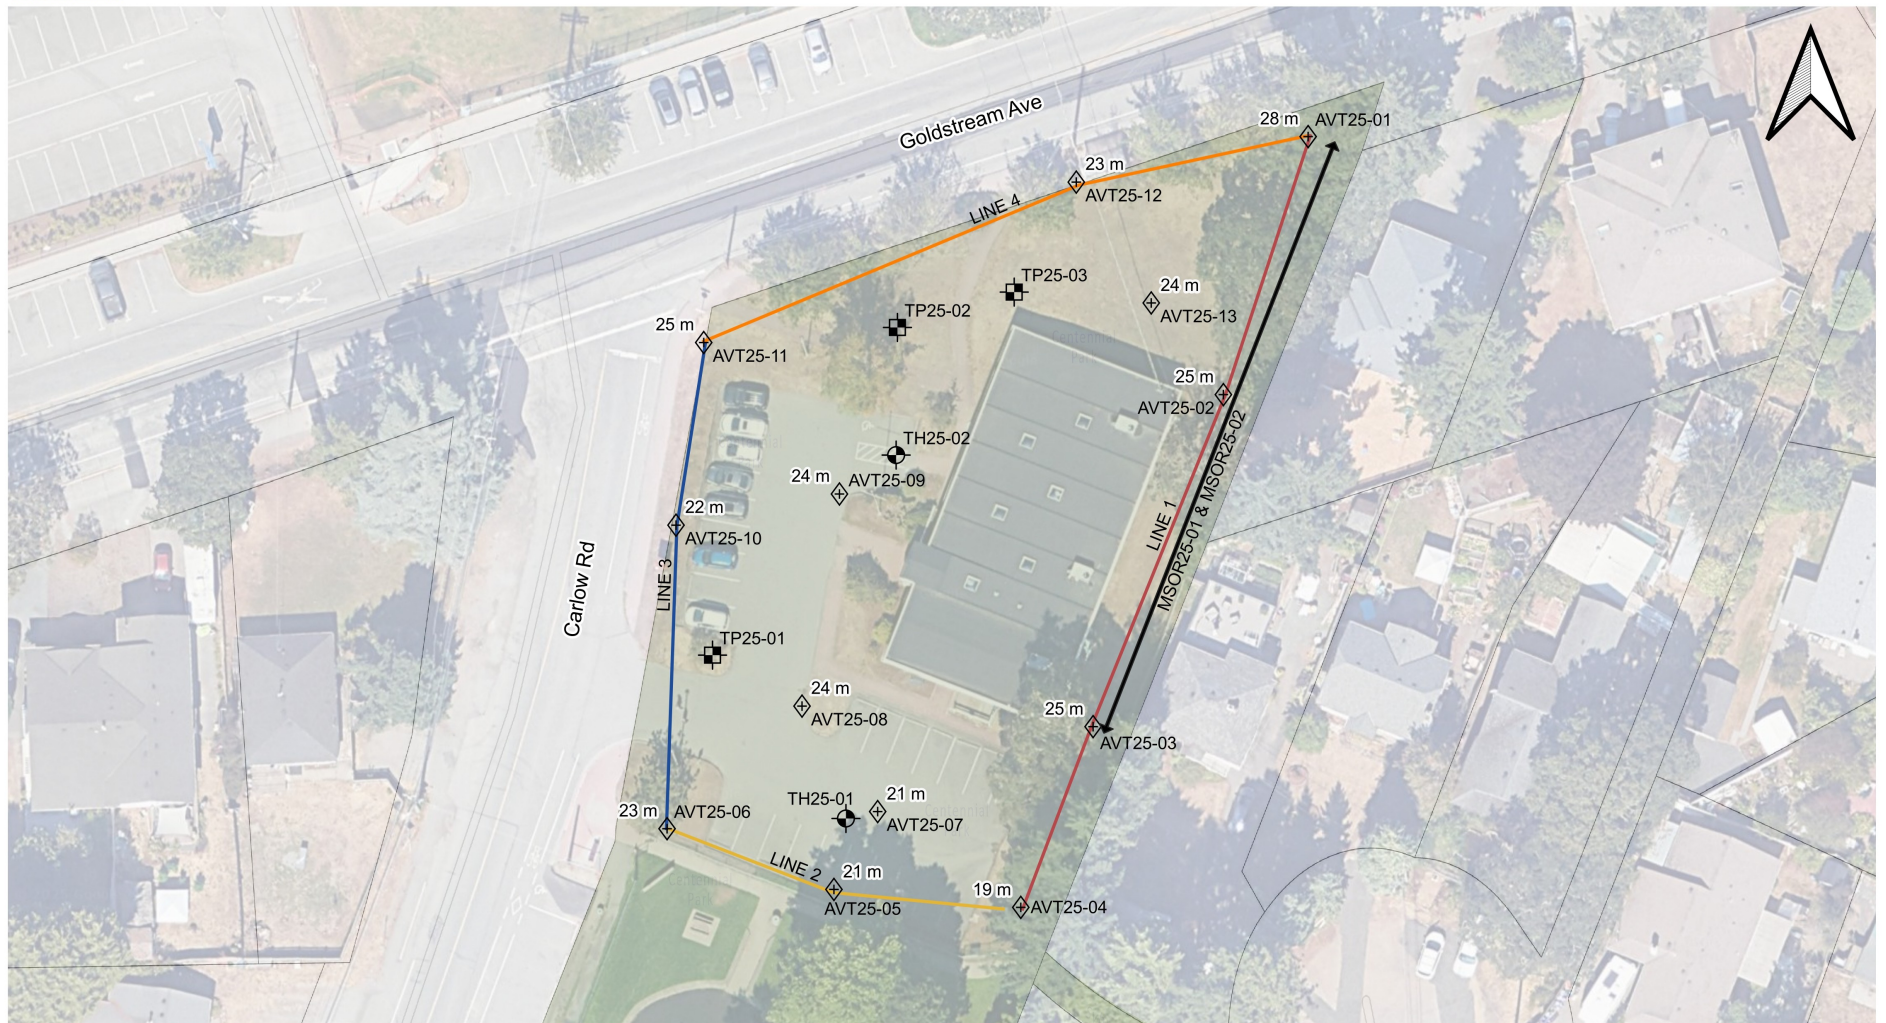
Figure 1- 2805 Carlow Road Site Plan

A sonic drilling investigation was carried out by Blue Max Drilling Inc. of Courtenay, BC, on October 8 to 10, 2025, using a Boart LS250 sonic drill rig. Two test holes (TH25-01 and TH25-02) were advanced to depths ranging from 22 m to 25 m. The test holes were logged in the field by a Thurber representative and were located using a Trimble survey device. The test hole locations are provided in Appendix A.

The test pits were logged in the field by a Thurber representative and were located using a Trimble survey device. The test pit locations are provided in Appendix A. Selected soil samples were collected from the test pit sidewalls and were returned to our Victoria laboratory for routine visual identification (ASTM D2488) and moisture content determination (ASTM D4959). The results from the test pit investigation and laboratory testing were used to compile the test pit logs and are provided in Appendix C of this report

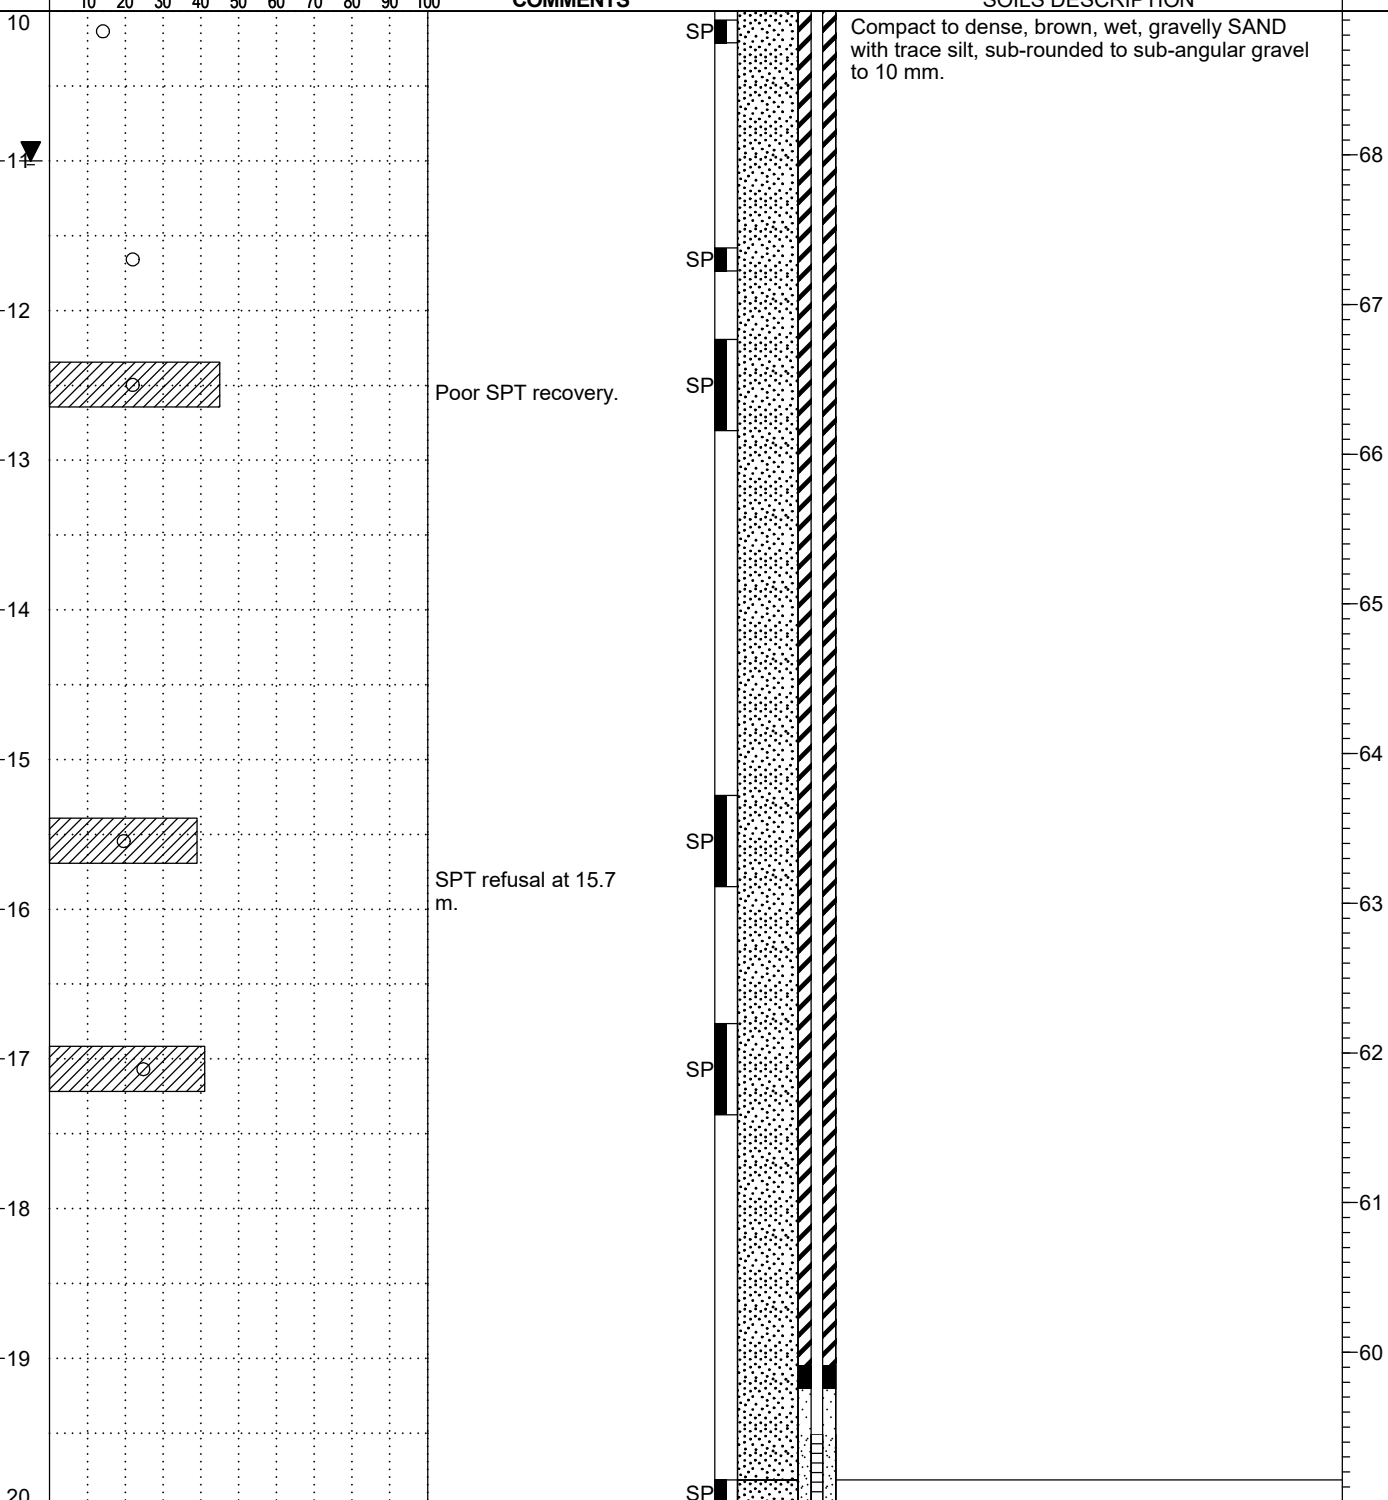
TEST HOLE NO.
TH25-01

Standard penetration tests (SPTs) were carried out at each test hole location. SPTs involve driving a split spoon sampler into the ground using a 63.5 g weight dropped from an approximate height of 760 mm. The number of blows required to advance the split spoon is recorded and provides an indication of the density and consistency of the subsurface soil. Practical refusal is typically determined when there is a high number of blow counts with little to no advancement. The SPT results are included on the test hole logs, provided as Appendix C of this report.

A groundwater monitoring well was installed within TH25-01, with the well screen installed at a depth of approximately 20 m. The test holes were backfilled with a combination of filter sand and soil cuttings and capped with bentonite-cement grout mixture. Flush-mount well covers were installed for both TH25-01 and TH25-02.

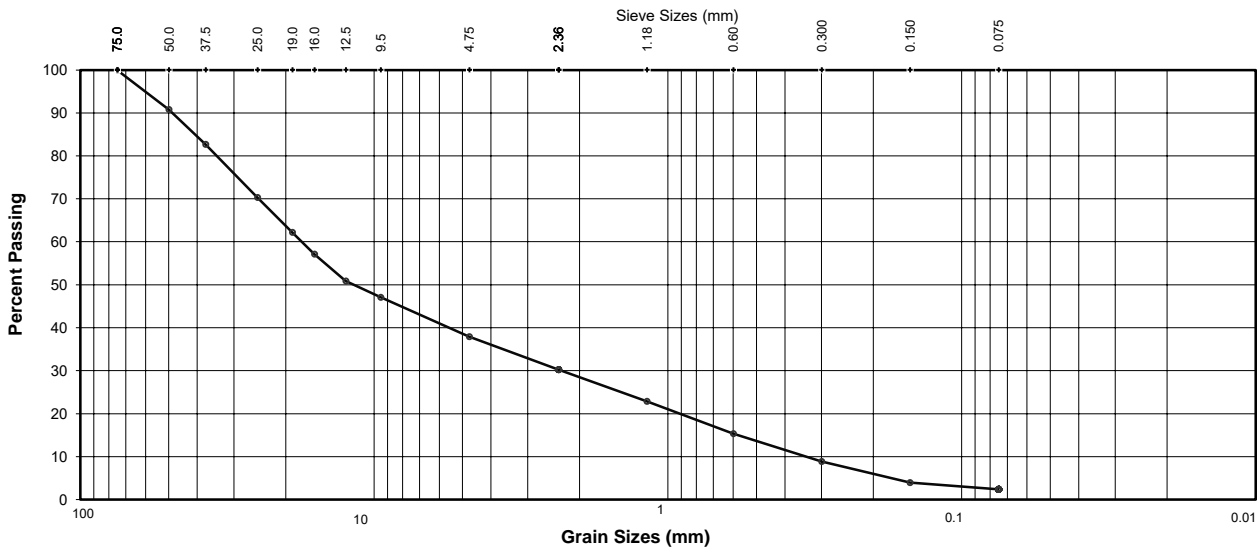
Sample Source: TP25-01, Sa. 2, 0.5m
Material Type: Grab
Specification:
Sample Description: brown, GRAVEL and SAND with a trace of fines
Water Content As Received: 2.8%

GRAVEL (FROM SIEVE)				
Sieve No.	Opening (mm)	Percent Passing	Gradation Limits	
			Max	min
	75	100.0		
	50	90.8		
	37.5	82.6		
	25	70.3		
	19	62.2		
	16	57.1		
	12.5	50.9		
	9.5	47.1		
	4.75	37.9

SAND & FINES (FROM SIEVE & WASH)				
Sieve No.	Opening (mm)	Percent Passing	Gradation Limits	
			Max	min
	2.36	30.3		
	1.18	22.9		
	0.6	15.4		
	0.3	8.9		
	0.15	4.0		
	0.075	2.4

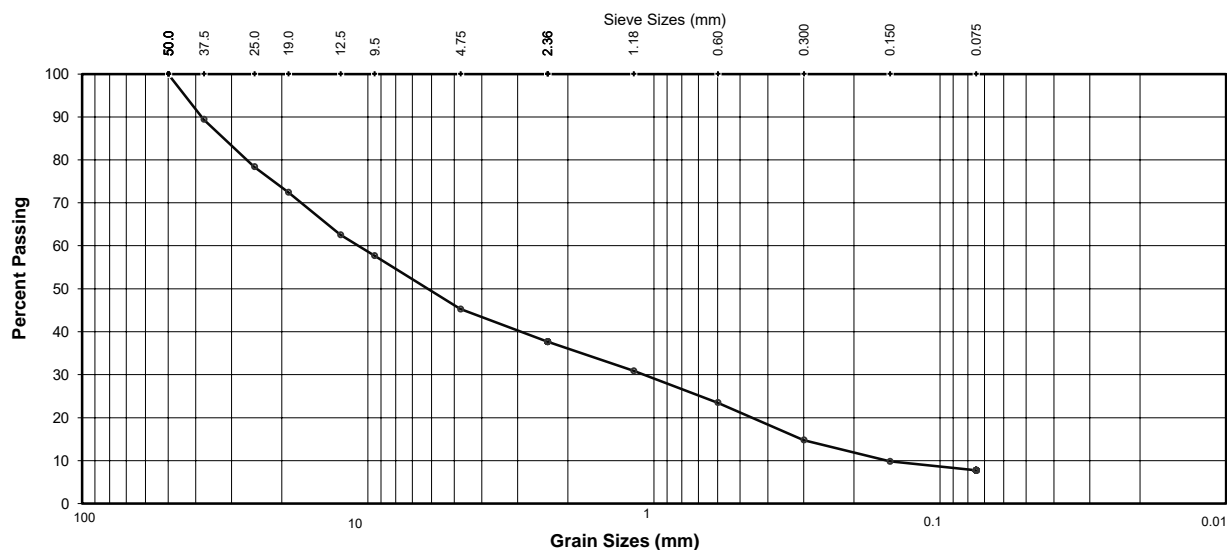
Sample Source: TP25-02, Sa. 1, 0.3m-0.45m
Material Type: Grab
Specification:
Sample Description: brown, GRAVEL and SAND with a trace of fines
Water Content As Received: 8.0%

GRAVEL (FROM SIEVE)				
Sieve No.	Opening (mm)	Percent Passing	Gradation Limits	
			Max	min
	100			
	75			
	50	100.0		
	37.5	89.4		
	25	78.4		
	19	72.5		
	12.5	62.6		
	9.5	57.7		
	4.75	45.3

SAND & FINES (FROM SIEVE & WASH)				
Sieve No.	Opening (mm)	Percent Passing	Gradation Limits	
			Max	min
	2.36	37.7		
	1.18	30.9		
	0.6	23.5		
	0.3	14.8		
	0.15	9.8		
	0.075	7.7		
				0

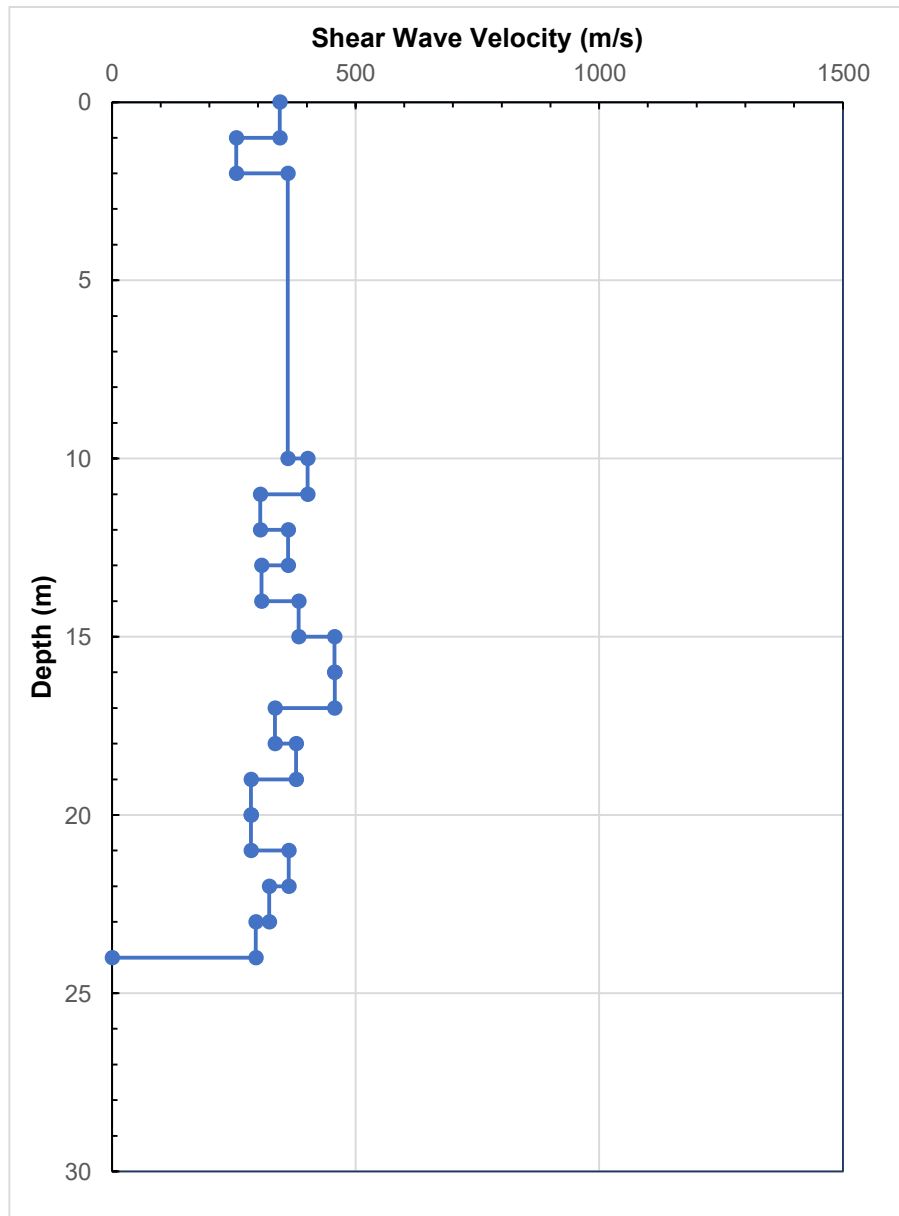
Client: M'akola
Test ID: TH25-02
Site: 2805 Carlow

A downhole seismic casing was installed in TH25-02 at the time of the investigation to a depth of 24 m. The downhole seismic casing consists of a 50 mm diameter PVC pipe grouted in place using a bentonite-cement grout intended to have a stiffness comparable to the in-situ soil stiffness. Thurber personnel completed the downhole seismic testing (DST) on October 22, 2025, after the grout was allowed to cure. Shear wave velocity testing was conducted in

accordance with ASTM D7400/D7400M-19 in 1.0 m intervals within the casing from ground surface to a maximum depth of 24 m.

Shear wave velocity measurements by Thurber Engineering Ltd.

We understand that the project is classified as “in-stream” and will therefore be designed using the seismic hazard from the 2018 British Columbia Building Code (BCBC) based on the National Building Code of Canada (NBCC) 2015 seismic hazard calculation provided in Appendix F. The 2018 BCBC and the 2015 NBCC specify a design level earthquake with a 2% probability of exceedance in 50 years, which corresponds to an average return period of 2,475 years. Based on the V_{s30} value obtained from the DST work carried out on this site, we consider a site class of C to be appropriate for this site. In the event that the NBCC 2020 hazard values need to be employed, a V_{s30} of 395 m/s can be employed for the determination of seismic hazard values.
