Staff Report to Sustainable Development Advisory Committee

SUBJECT: Application to Rezone 3405 Happy Valley Road from Rural Residential 2 to Residential Small Lot 1 (RS1) to allow for 13 single-family lots.

Arborist Report

3405 Happy Valley Road,
Langford, BC V9C 2X9

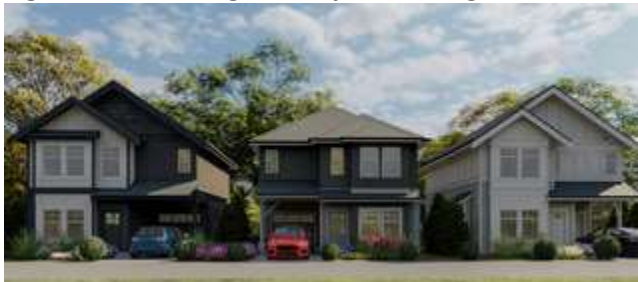
Figure 3: Renderings of Proposed Design

The subject property is located in the Potential Habitat and Biodiversity Area and will require an Environmental Assessment completed by a registered professional biologist as part of the development permit application, should this rezoning be approved. A development permit will also be required to address the Intensive Residential design guidelines, prior to Subdivision Approval. Figure 3 below illustrates the proposed design of the small lot homes:

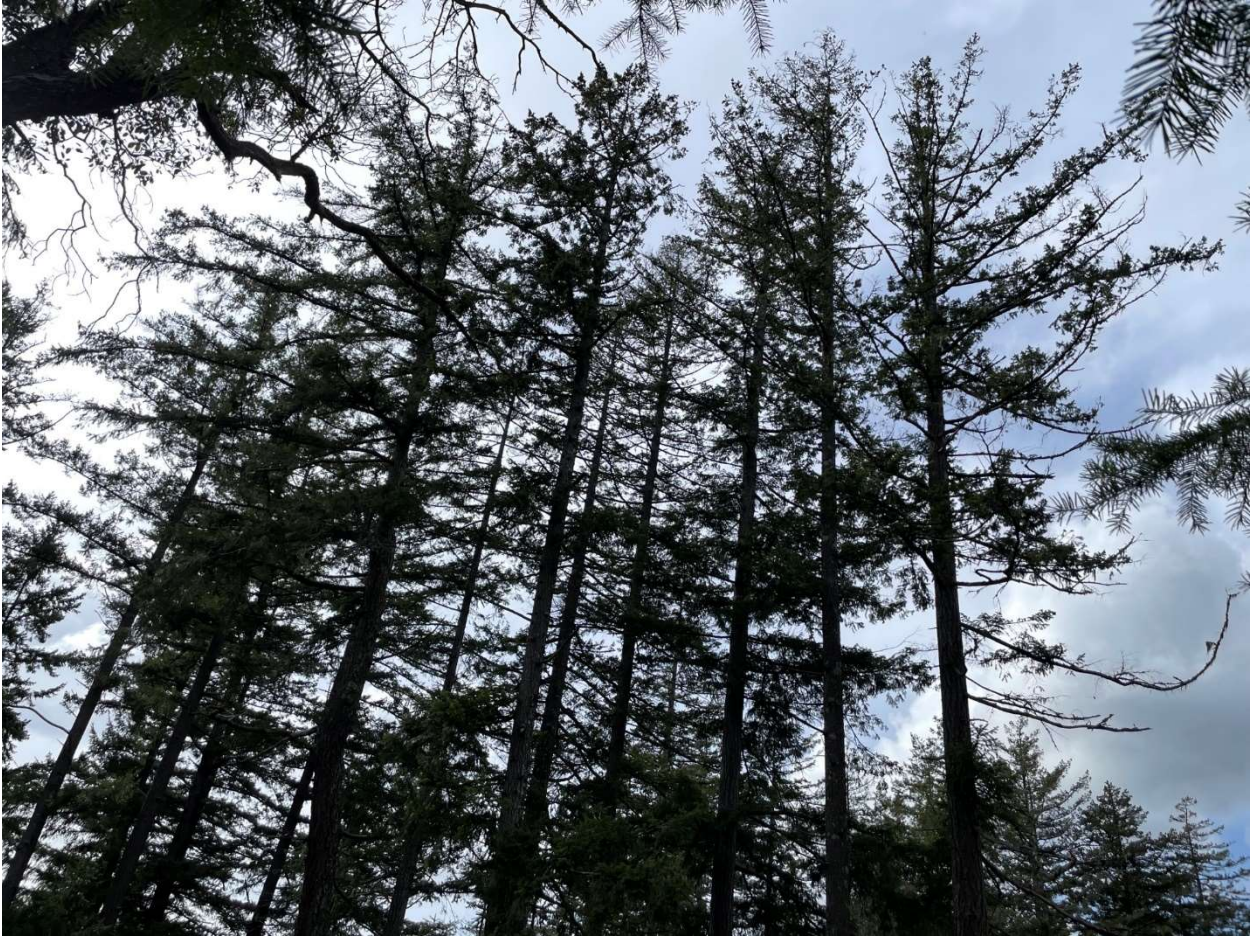
Figure 3. Park Tree Canopies. Deadwood and dieback visible in most of the canopies.

The trees located on the proposed park dedication (tagged 451-458 and 738) are all Douglas firs located on the eastern side of the lot. If the proposed development is approved and the houses built, the trees of concern would pose a high risk over the next two years. The trees were observed to be shallowly rooted on bedrock with limited available soil volume for anchoring. Laminated root rot, *Phellinus weirii*, is suspected to be present in many of these firs. The development activities that have occurred surround the site have likely changed the hydrology, a factor that will be further affected by the planned development on the site. Winds are often funneled through the Happy Valley. Once the site has been cleared for the planned development, the trees of concern will be almost fully exposed, except by southwesterly winds, thus increasing the likelihood of failure to probable. Due to the proximity of existing and proposed houses within one tree length on three sides the likelihood of impact is considered to

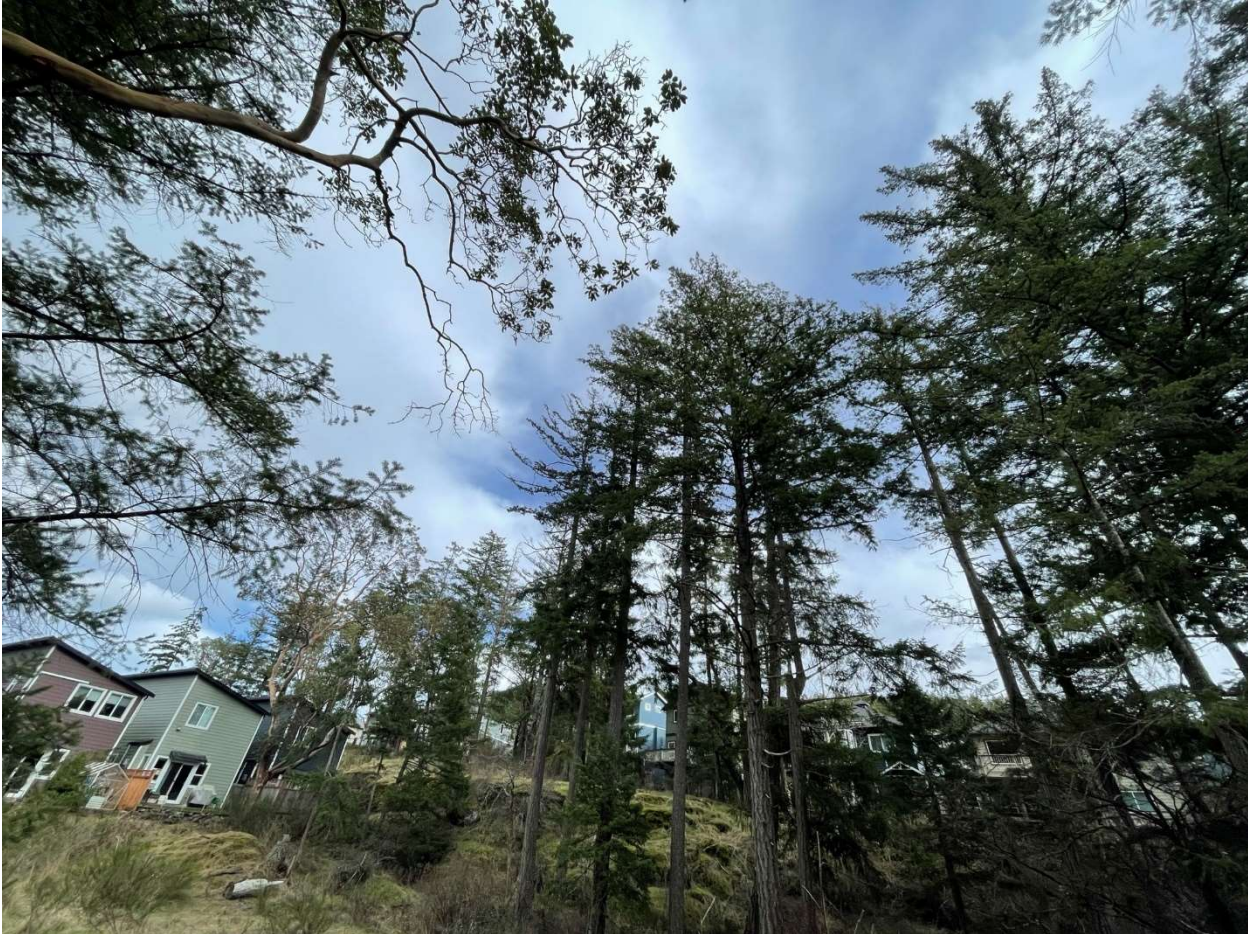
Figure 4. Southern section of site. Note rocky outcrops and existing houses.

The use of blasting for removal of rock may cause serious damage or death to nearby trees if not managed appropriately. CTS recommends the use of low nitrogen and low velocity explosives. Furthermore, we recommend the use of explosives to strategically fracture the rock before using an excavator to breakup (using a hoe ram) and remove the rock. It is critical that ¾" plywood is used to protect (armour) retained trees and that heavy matting is used to dampen shockwaves. A removal plan for the rock will be developed with the blasting contractor and the Project Arborist. It is recommended that this plan is created prior to the blasting contractor providing a cost estimate.
